Technical Report

**Weathertightness testing an Argeton
Rainscreen system of terracotta**

**N950/07/13946/REV01
16 OCTOBER, 2007**

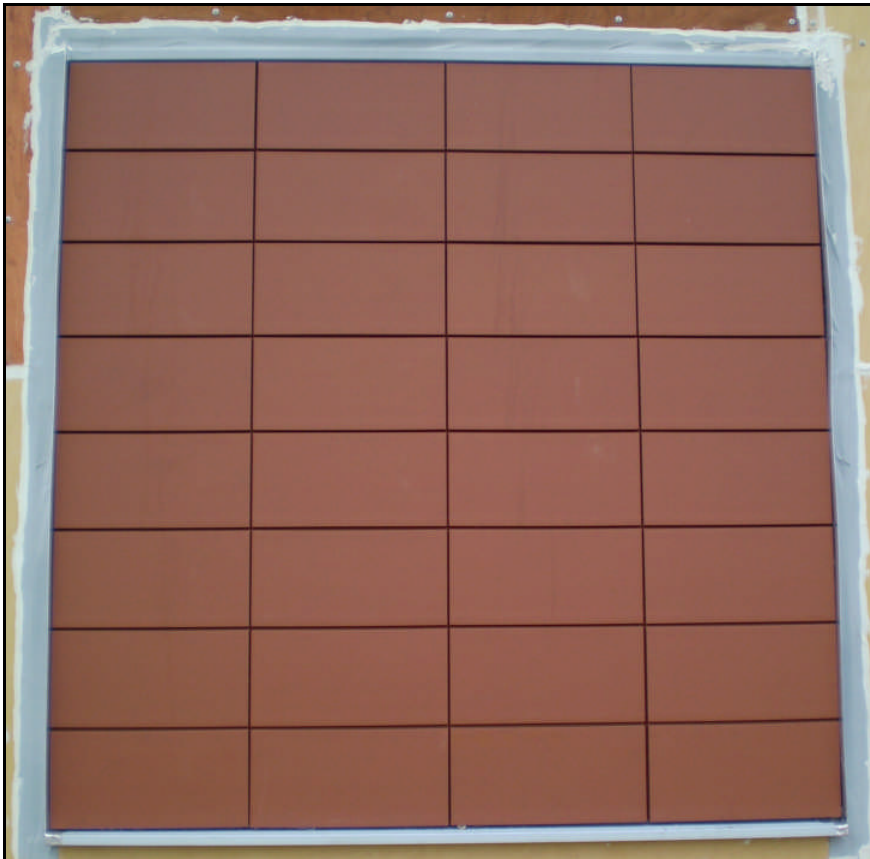
PHOTO 00013

The sample was as shown in the photo below and the drawings included as an appendix to this report.

The tiles measured 600 mm wide by 300 mm high and were supported by vertical rails at 600 mm centres.

The aluminium rainscreen carrier frame was secured to the backing wall framework with 2 coarse thread self drilling Tek screws at each fixing position.

TEST SAMPLE ELEVATION

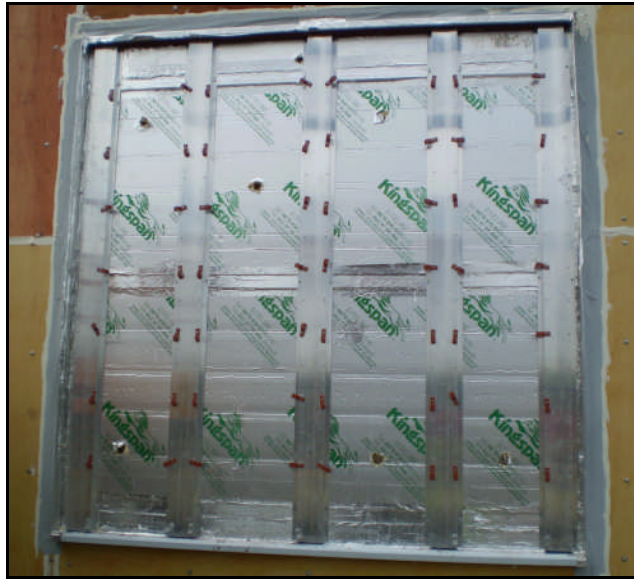
PHOTO 20027

During the dismantling of the sample no discrepancies from the drawings were found.

VERTICAL SUPPORT RAILS

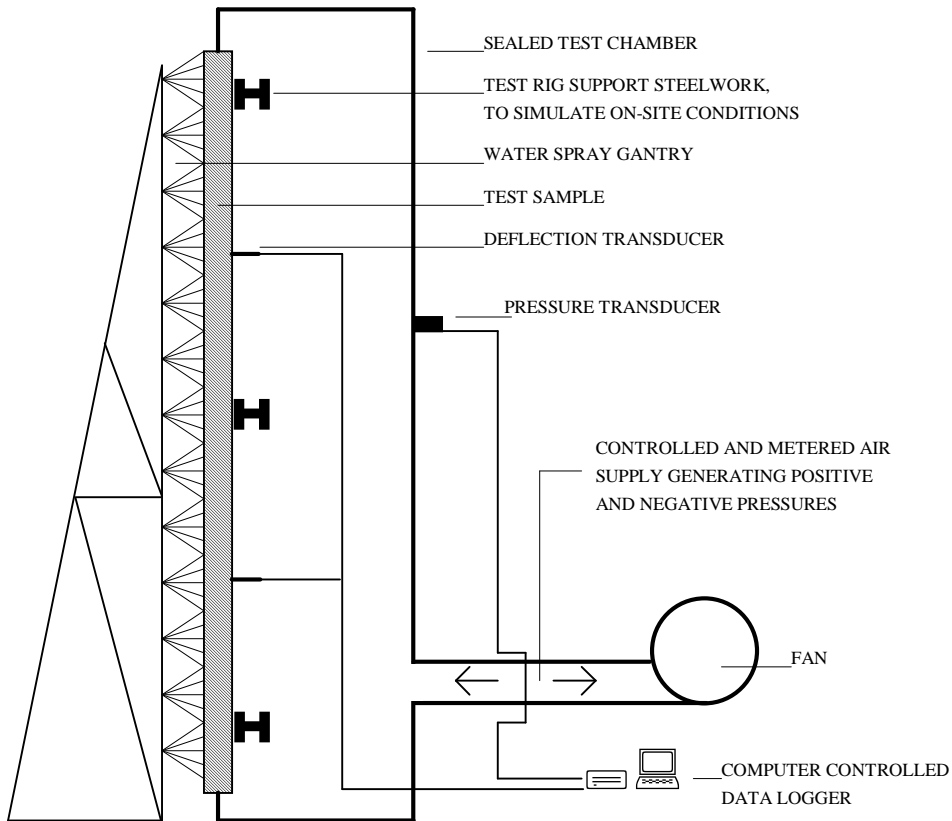
FIGURE 1

The test sample was mounted on a rigid test rig with support steelwork designed to simulate the on-site/project conditions. The test rig comprised a well sealed chamber, fabricated from steel and plywood. A door was provided to allow access to the chamber. Representatives of Telling installed the sample on the test rig. See Figure 1.

TYPICAL TEST RIG GENERAL ARRANGEMENT

SECTION THROUGH TEST RIG

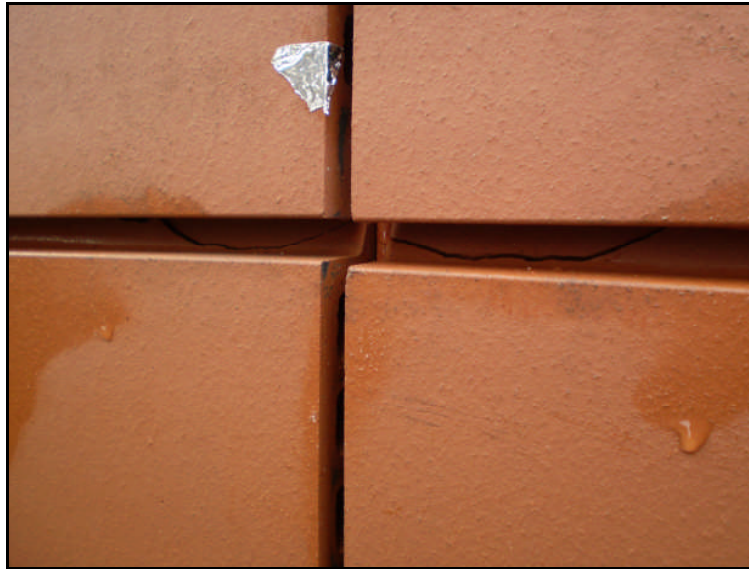
PHOTO 20018

500 Nm. The impact cracked the top of the tiles below. The tiles remained secure. See photo 20018.

LOCATION 2 IMPACT

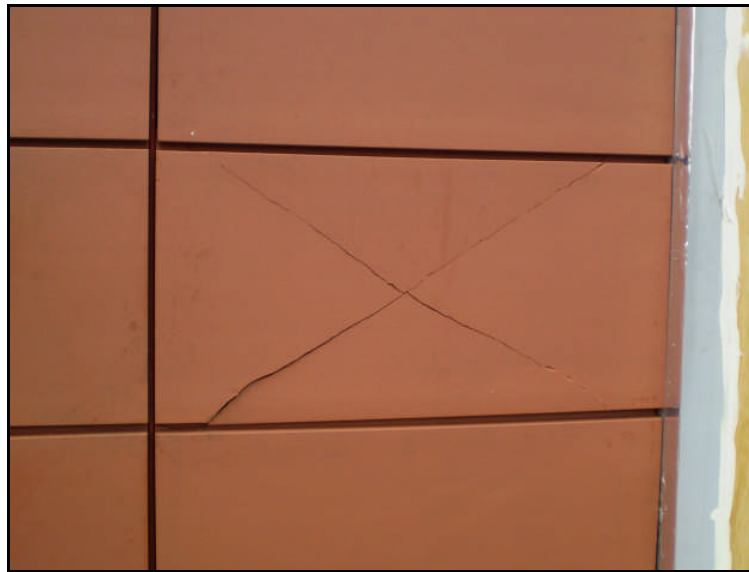
PHOTO 20025

10 Nm hard body. The tile cracked but remained secure. See photo 20025.

LOCATION 7 IMPACT
